Lake Oglethorpe Water Quality Report

Date: June 25, 2015

Study Period: Nov 2014-May 2015

Principle Investigator: Chad Andrews, EIT

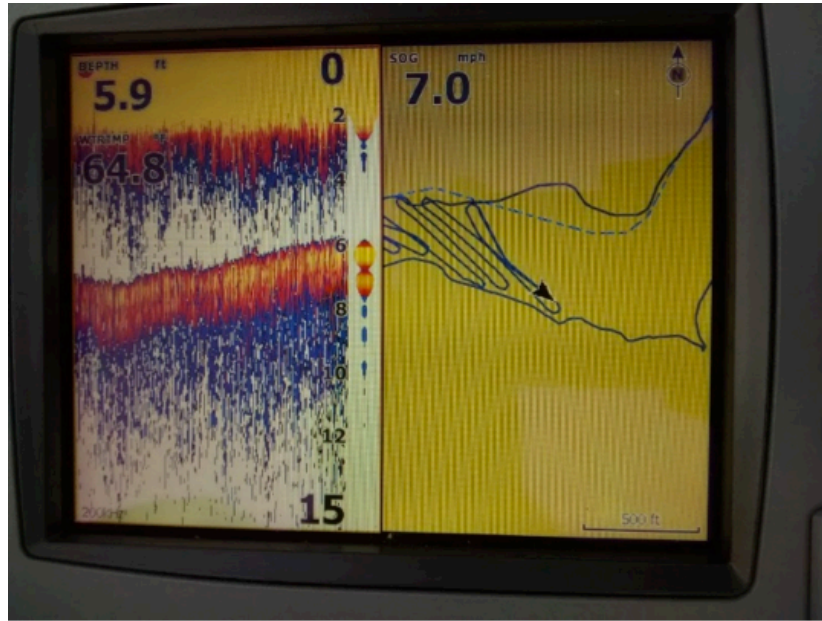
Figure 5.1- *Lowrance Sonar Screen Display.* As demonstrated on the right half of the picture, data points were gathered on the periphery of the lake and also in zigzag lines from bank to bank. Water depth data is displayed on the upper left portion of the screen display.

Sonar depth and GPS data was collected on March 31, 2015 and sent to a third party to be analyzed. A total of 4,995 data points were analyzed via online lake monitoring software called BioBase. A completed bathymetric map can be seen in **Figure 6.6**. The area of Lake Oglethorpe was measured to be 61.29 acres with a total volume (as of March 31, 2015) of 510-acre ft., 629,935 m³, or about 250 Olympic swimming pools. This area did not include the mouth of the lake above the bridge. The largest depth measurement was gathered at a point near the dam and reached 27.1 feet. It was also determined the lake had less than 3% vegetation on the bottom, which is probably due to grass carp.

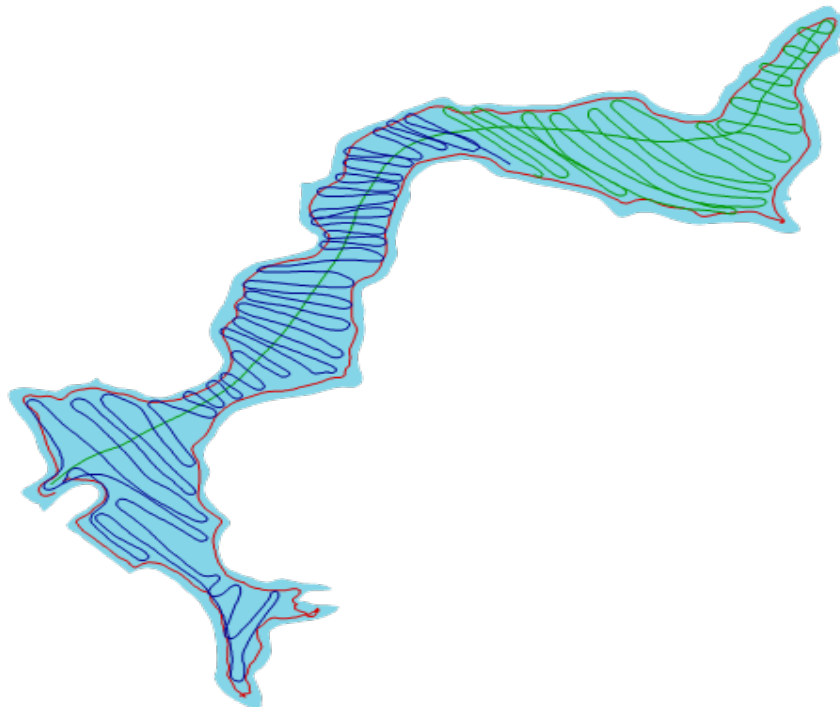
Figure 5.2. *Oglethorpe Lake Profile Generated from Sonar Data.* Collected sonar data was analyzed via BioBase, a lake monitoring online software. The different colors represent the three different sets of data.

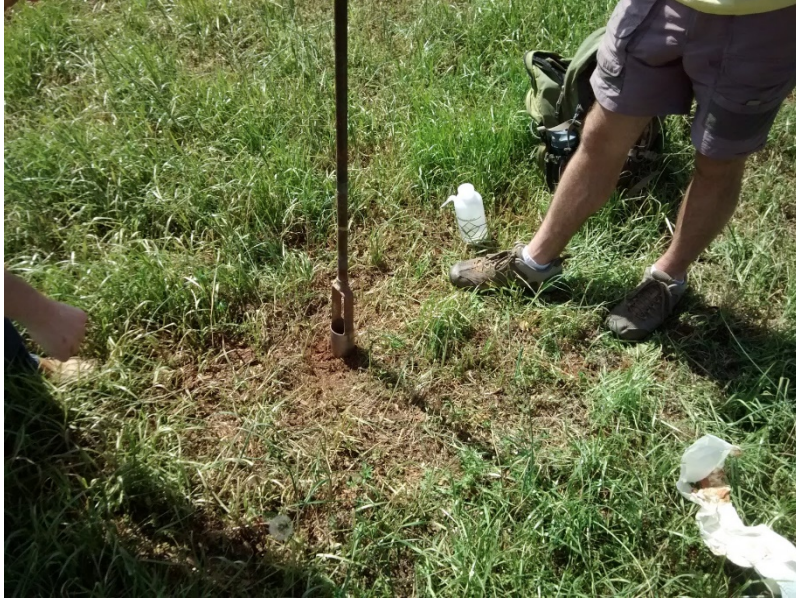
Figure 5.5- Soil sampling technique using steel hand auger in pasture

Soil samples were collected from within each of the aforementioned subzones comprising the overall 3.47 square mile catchment area for Lake Oglethorpe (**Figure 5.5**). Careful attention was given to the different forms of land cover that made up each subzone. Find a low-lying area representative of the greater subzone. Remove top-layer of grass/debris from the sampling spot. Clean the stainless-steel hand auger with distilled water. Plunge the auger into the soil near the chosen sampling spot for further cleansing. Remove the auger and dislodge the soil from the cylinder. Plunge the auger into the chosen sampling spot. Retrieve a sampling core (4 inches deep for pasture, 6 inches deep

for forest). Empty the sample into a labeled Ziploc gallon bag. A Garmin Etrex GPS device was used to record the position of sampling. Data was documented for the date and time to the nearest minute that the sample was taken.

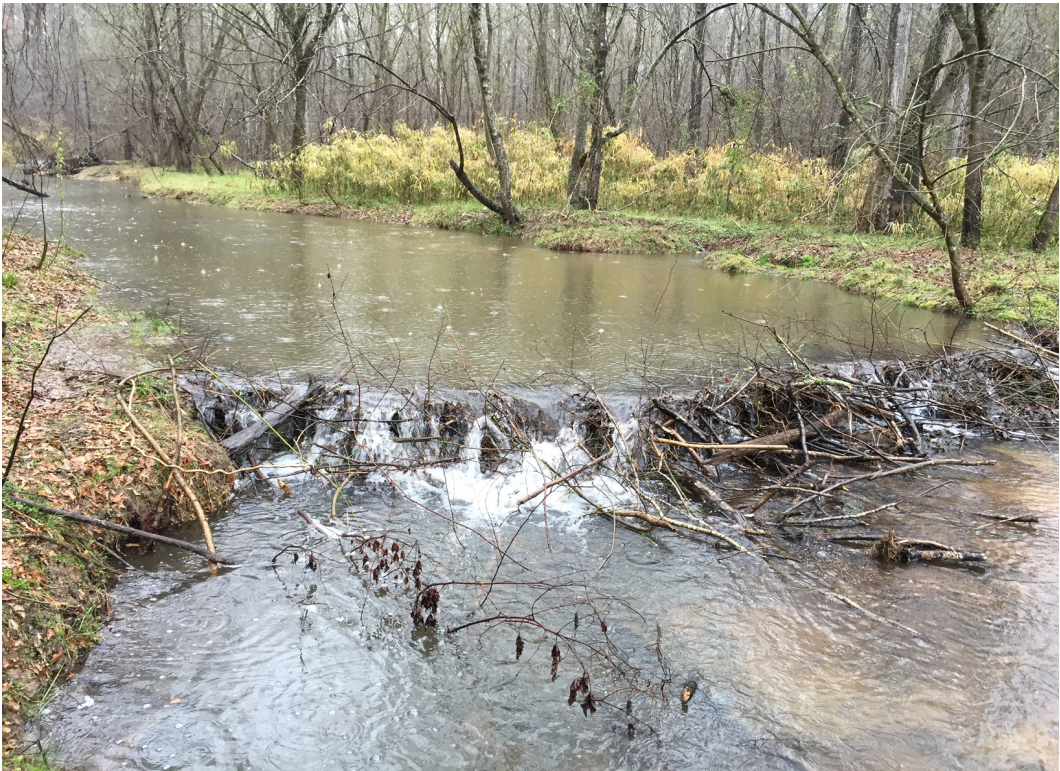
Figure 6.8- One of approximately 7 Goulding Creek beaver dams on 3/19/15

While sampling Goulding Creek, the observation was made that several large beaver dams had been constructed. A photo can be found in **Figure 6.8 and 6.9**. These dams drastically altered the discharge of the main tributaries filling the lake. Where there used to be a base flow of approximately five inches deep, there now were two to three feet of almost completely stagnant water. The beaver dams made it impossible to calculate discharge of Goulding Creek into the lake. A figure of the recorded stage can be seen in **Figure 6.10**. Notice the low stage in the first few months and a gradual incline to around 3 feet. These beaver dams could potentially have an effect on the water quality of Lake Oglethorpe for the better, but more time and data is necessary to make an accurate analysis of this statement. For the future interest of the lake, the beaver dams were left intact.

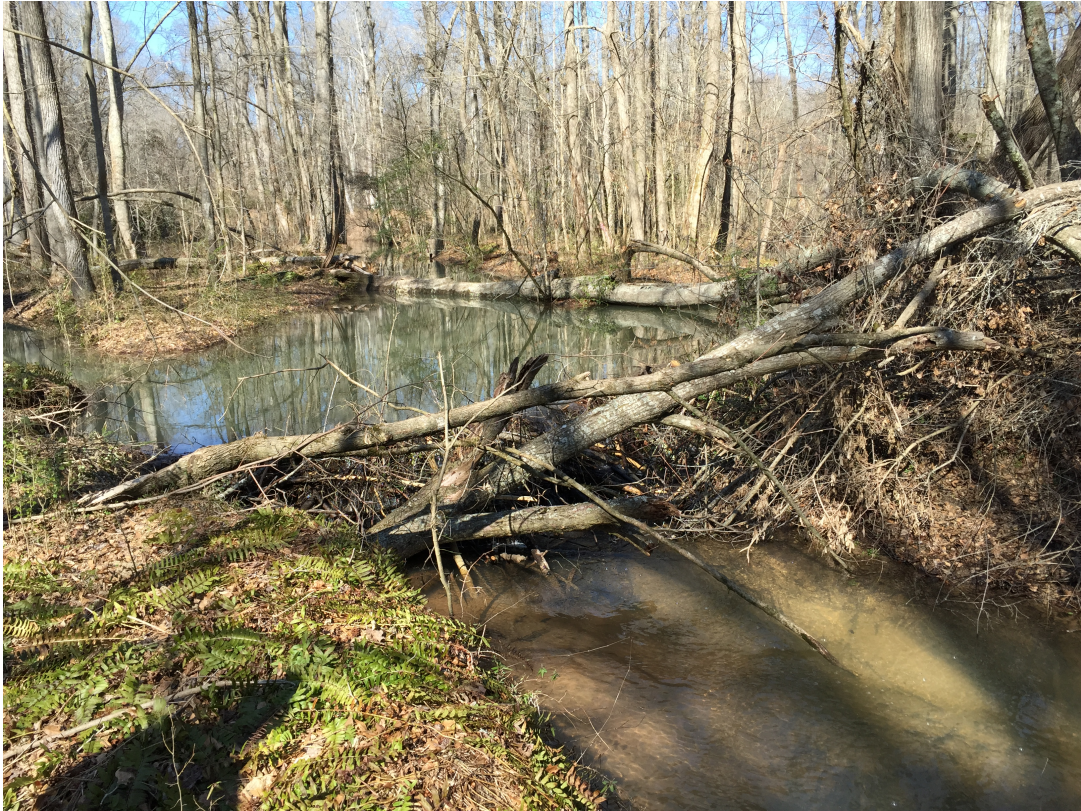
Figure 6.9- Goulding Creek dam photo 2

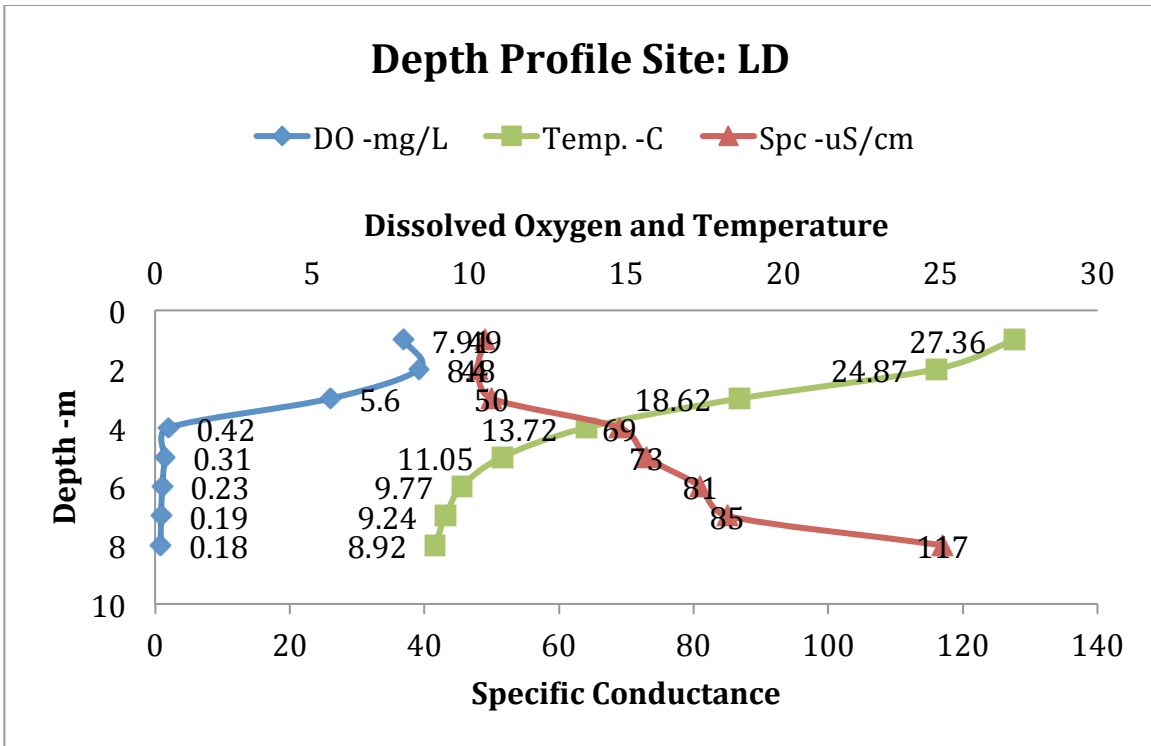
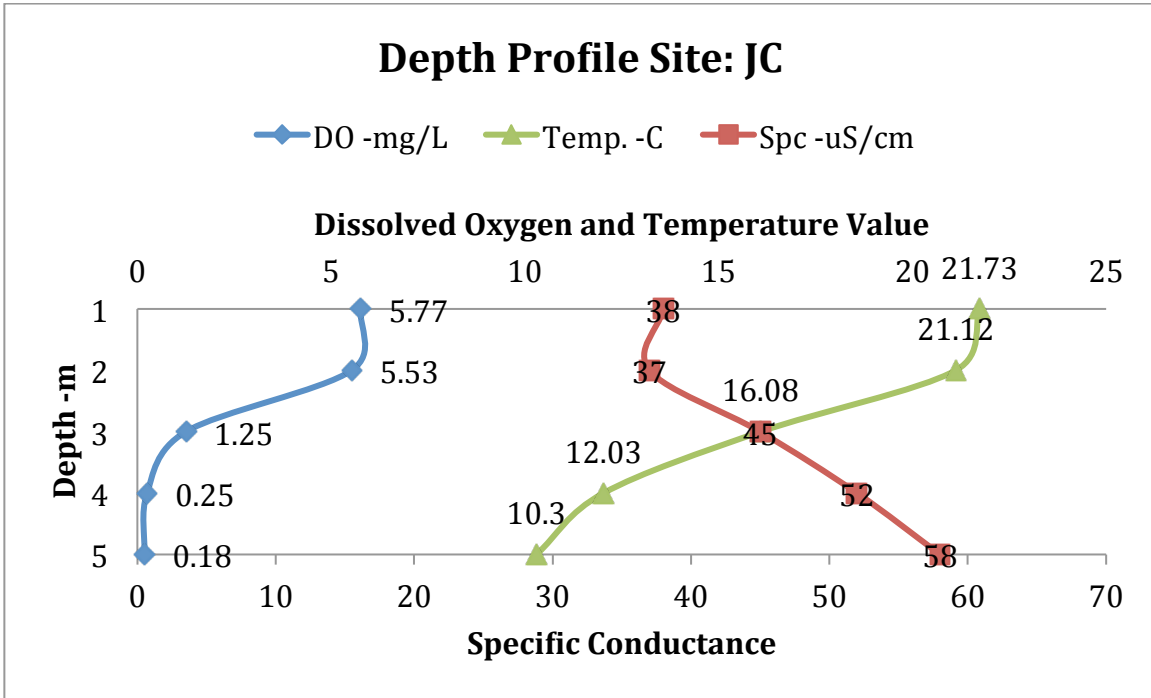
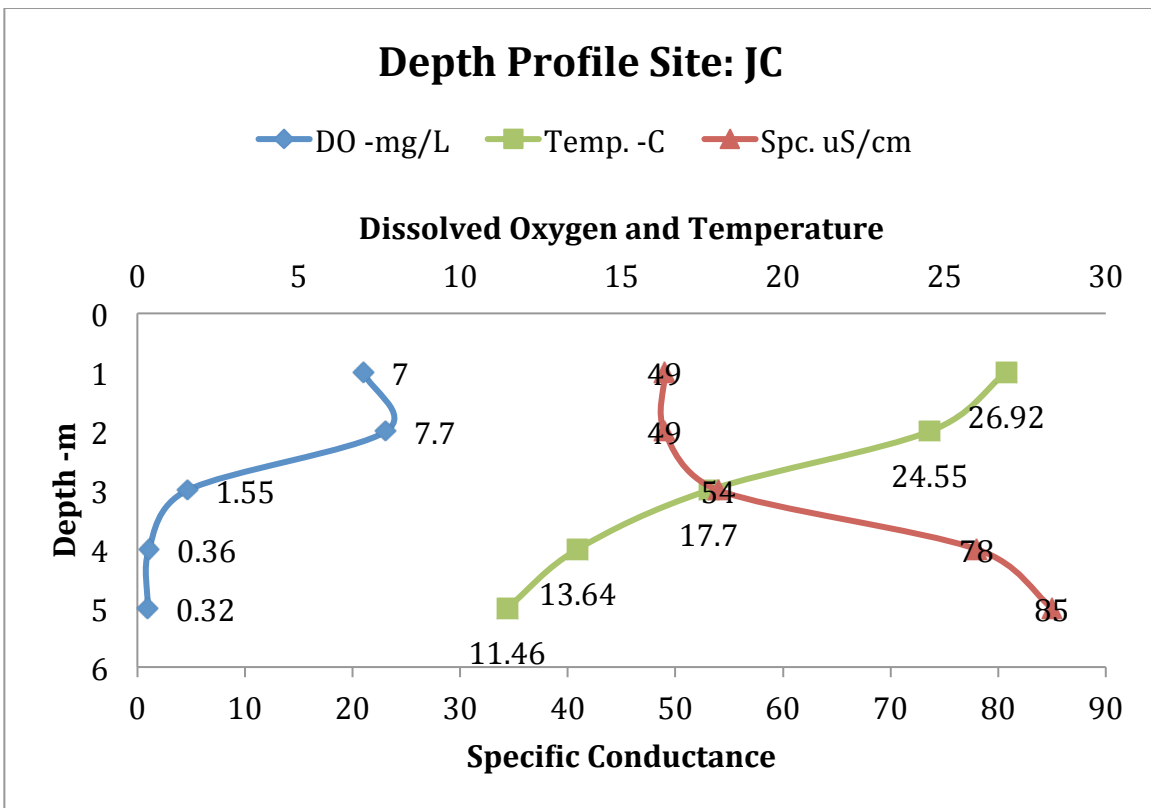
Figure 6.12: Lake Dam site depth profile sampled April 28, 2015

Figure 6.13- Lake Dam site depth profile sampled May 18, 2015

Figure 6.14: Johnson Cove depth profile sampled April 28, 2015

Figure 6.15: Johnson Cove site depth profile sampled May 18, 2015

Figure 6.16: Athens Cove depth profile sampled April 28, 2015

Figure 6.17: Athens Cove site depth profile sampled May 18, 2015

A total of 7 sites were sampled around the lake. **Figures 6.12-6.24** include all the data gathered at each location. It can be seen that specific conductance data increases with depth at each stratified location, while it remained similar in the mixed zones. Temperature decreased with depth similarly at each location.

The anoxic zone at each location started around 2.5-3 meter, in which dissolved oxygen fell towards anoxic conditions. Sample locations more shallow than 3 meters were fully mixed. Based on the data, it was concluded any depth below 3 meters could be considered anoxic when the lake is stratified. This data correlates with historical dissolved oxygen data of Lake Oglethorpe and confirms the location of lake aeration diffusers.

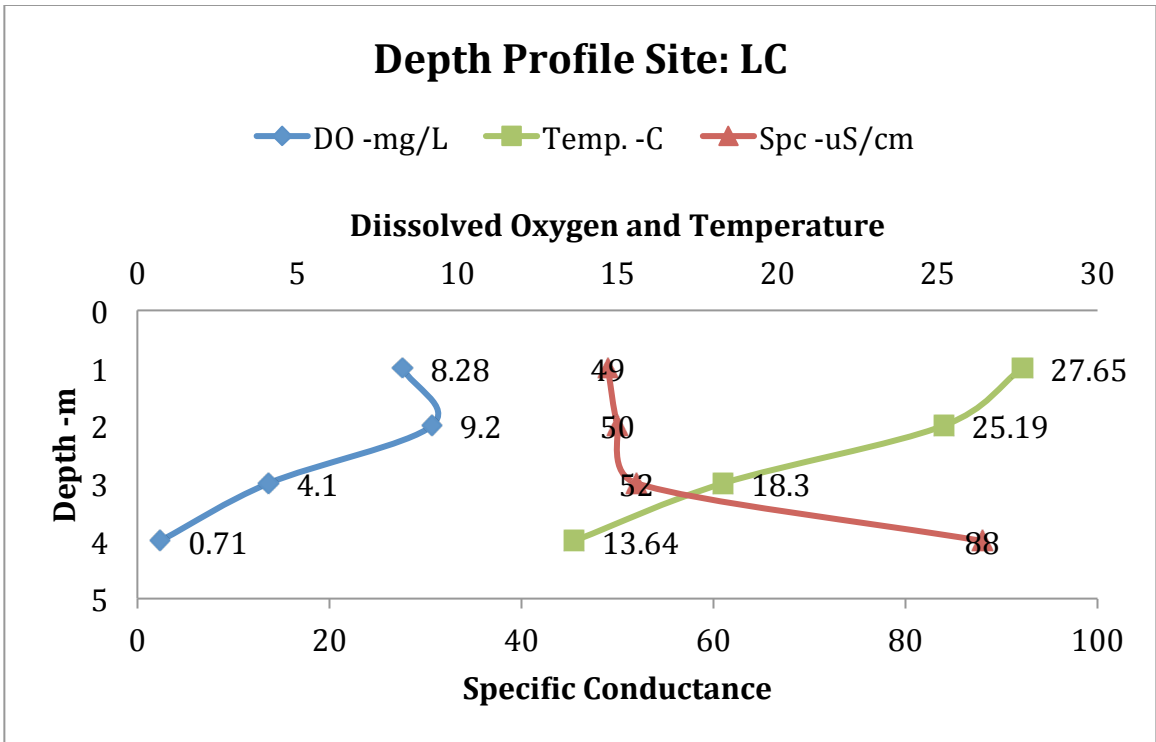
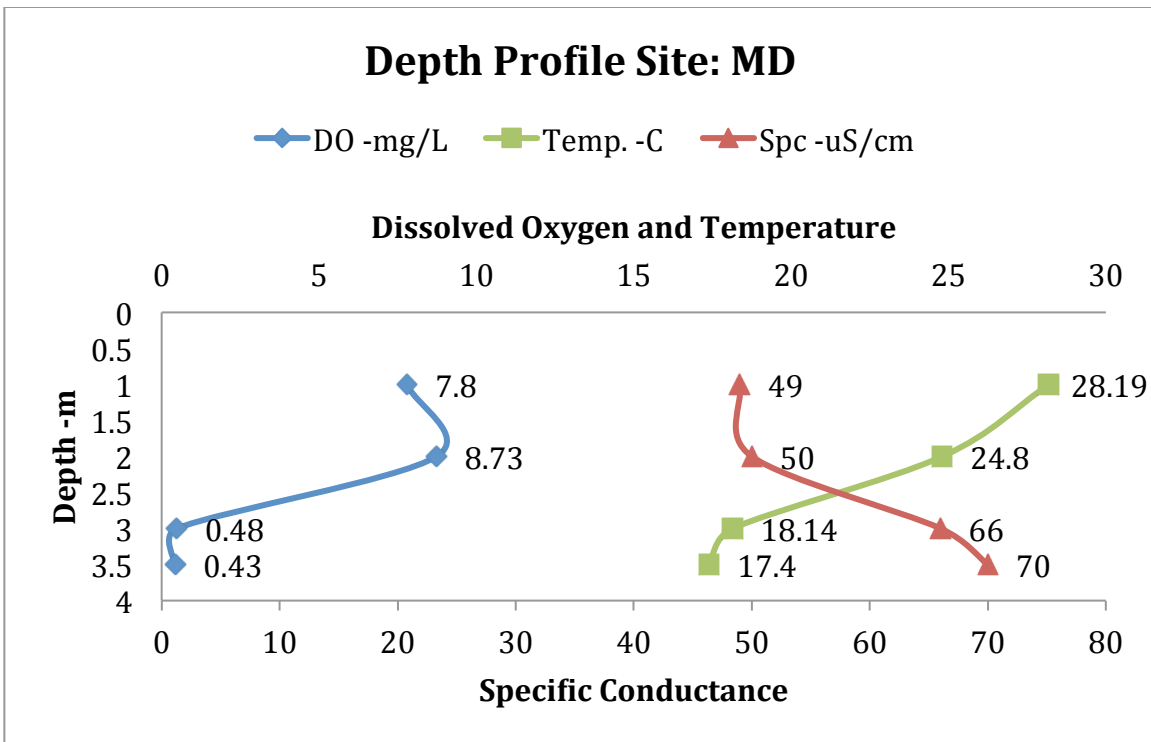
Figure 6.18- Lake Center depth profile sampled April 28, 2015

Figure 6.19: Lake Center depth profile sampled May 18, 2015

Figure 6.20- Middle Depth lake site depth profile sampled April 28, 2015

Figure 6.21- Middle depth lake site depth profile sampled May 18, 2015

Figure 6.22- Lake Transition depth profile sampled April 28, 2015

Figure 6.23- Lake Transition depth profile sampled May 18, 2015

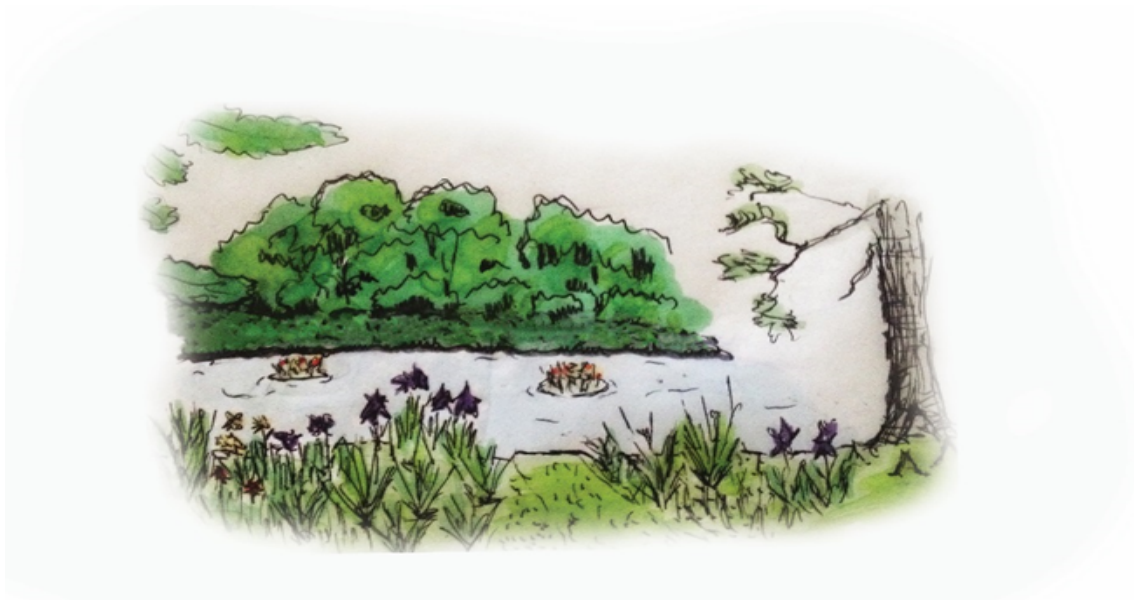
Figure 7.7- Illustration of floating wetland and native buffer plants

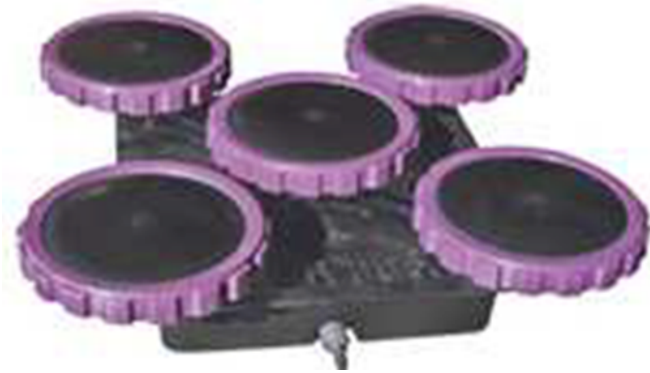
Figure A2- Aeration diffusers

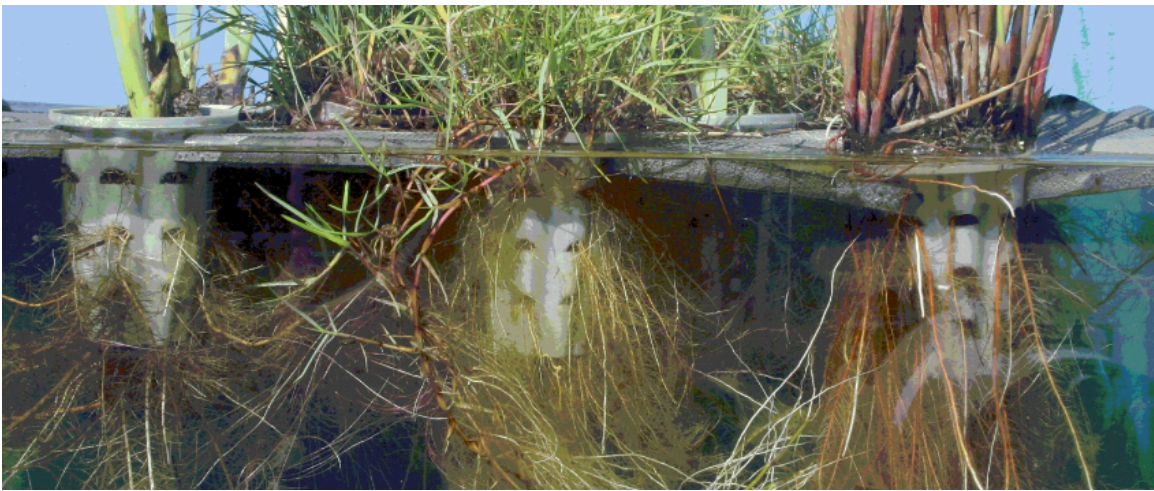
Figure A3: Floating Wetland below surface
